**LABORATORY MEASUREMENT OF
THE REDUCTION OF
TRANSMITTED IMPACT SOUND OF
VINYL FLOORING
(ACCORDING TO ISO 10140-3)**

**LABORATORY MEASUREMENT OF THE
REDUCTION OF TRANSMITTED IMPACT
SOUND BY FLOOR COVERINGS ON A
STANDARD FLOOR.**

Reduction of impact sound pressure level according to ISO 10140-3
laboratory measurements of the reduction of transmitted impact sound by floor coverings on a heavyweight reference floor

No. of test report: T1746

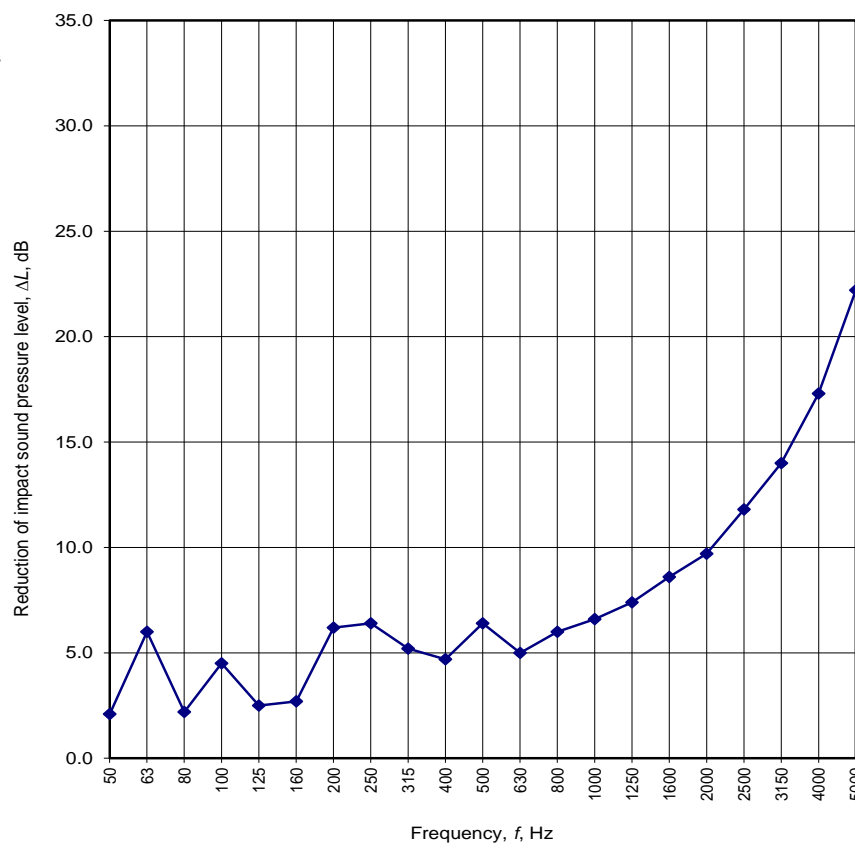
Frequency <i>f</i> Hz	<i>L</i> _{<i>n,o</i>} One-third octave dB	ΔL One-third octave dB
50	54.4	2.1
63	50.0	6.0
80	56.8	2.2
100	63.7	4.5
125	65.8	2.5
160	66.1	2.7
200	68.7	6.2
250	72.1	6.4
315	71.3	5.2
400	69.9	4.7
500	74.2	6.4
630	72.0	5.0
800	71.2	6.0
1000	71.3	6.6
1250	71.3	7.4
1600	71.1	8.6
2000	72.0	9.7
2500	72.5	11.8
3150	72.6	14.0
4000	71.1	17.3
5000	68.2	22.2

$\Delta L_w = 10$ dB $C_{I,\Delta} = 4$ dB $C_{I,r} = -8$ dB $C_{1,50-2500} = -7$ dB

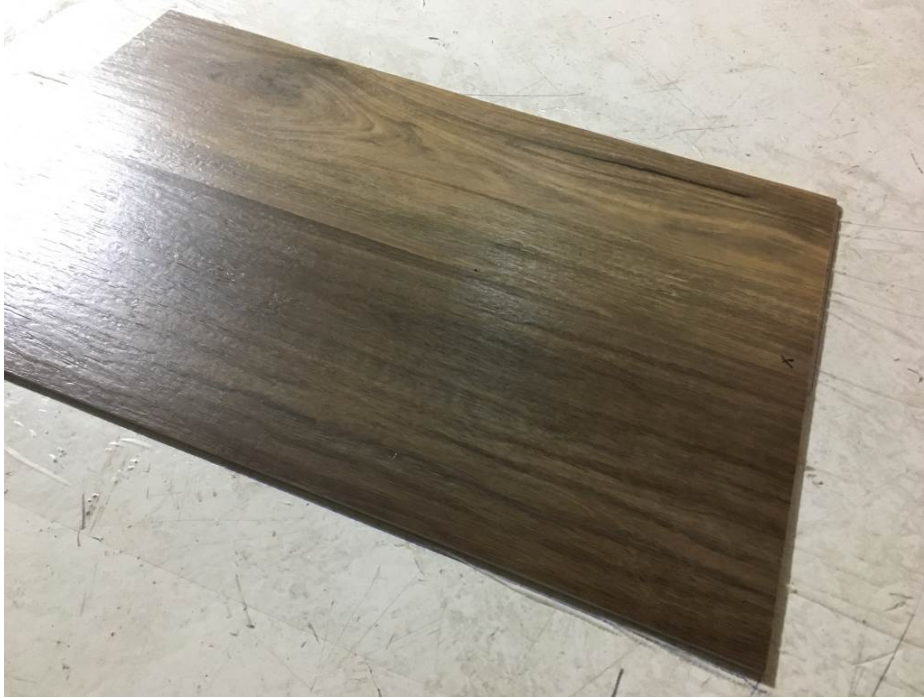
Figure 1: LG Decotile Plus Vinyl flooring adhered to concrete slab

Flooring: LV Decotile Plus Vinyl flooring
Flooring adhesive: Uzin Pressure Sensitive adhesive
Underlay: No underlay
 Concrete Slab

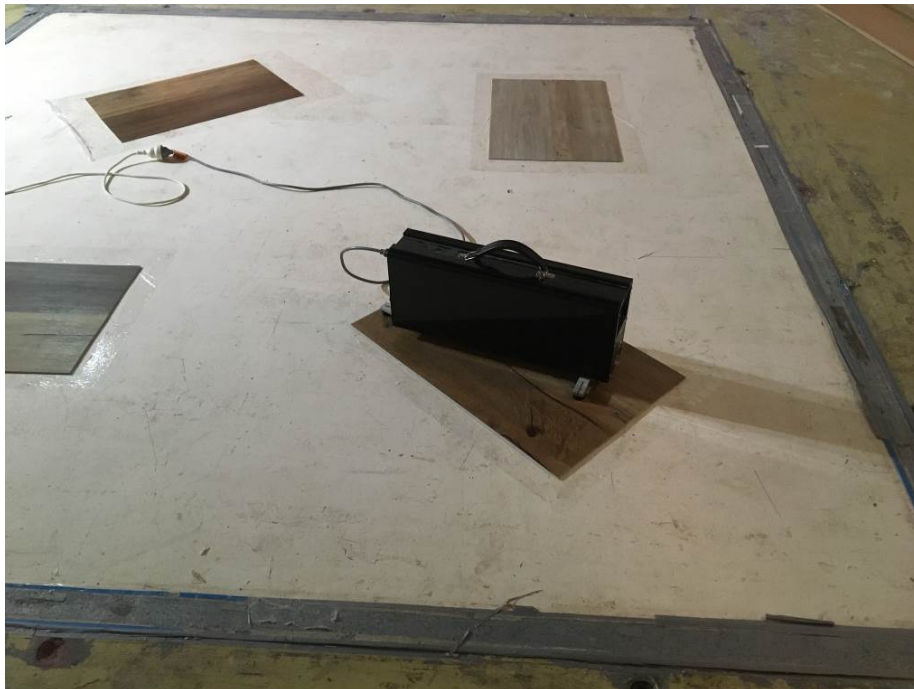
Figure 2: Tapping machine on vinyl sample on test floor

The BK3204 tapping machine is placed sequentially in four different positions on the floor. The impact sound pressure level is measured in the room below the floor, using a rotating microphone, in third octave frequency bands. The impact sound pressure levels are normalized against the room absorption. The room absorption is calculated from the reverberation time and room volume. The reverberation time is measured from the decay of a steady state sound field.

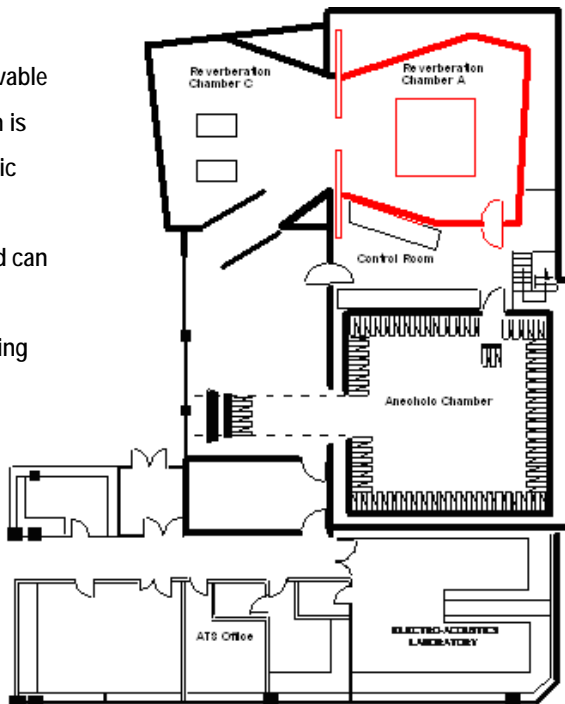
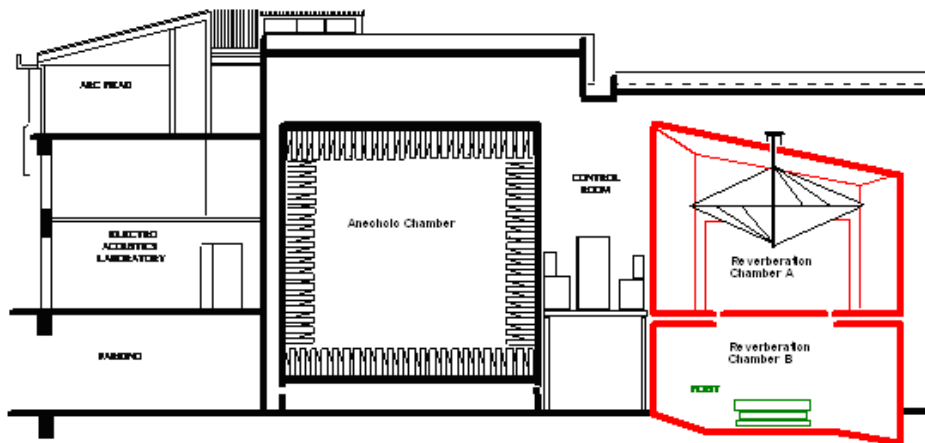
All three reverberation chambers may be described as hexagonal prisms; each having 6 vertical sided walls, perpendicular to the floor. The roofs of chamber A and C are plane, but inclined at 12 degrees from horizontal. Chamber B has a plane, horizontal roof which is the floor of chamber A above it. The floor of chamber B is also horizontal, but has two angled sections at its north west and south east ends. The centre section is horizontal because a floor jack is installed there. The floor jack may be raised hydraulically to the ceiling of chamber B, the centre of which consists of a floor plug between the two chambers. This plug may be disconnected from chamber A and lowered down into chamber B, leaving a 3.2m x 3.2 m opening between the two chambers. This allows for the measurement of airborne and impact insulation of floor and roof elements.

The three Reverberation Chambers are linked by heavy steel doors and a removable Standard Industrial Floor Section which is removed and repositioned by a hydraulic hoist. The three chambers are vibration isolated from one another so that sound can only pass from one to the other via the intervening Test Wall or Test Floor/Ceiling
